STRUCTURES INSPECTION FIELD REPORT

B-16-053

CITY/TOWN BOSTON		8-STRUCTURE NO. B16053-4T3-DOT-NBI		11-Kilo. POINT 212.910	41-STATUS A:OPEN	90-ROUTINE INSP. DATE MAR 30, 2022
07-FACILITY CARRIED HWY BROOKLINE AV		MEMORIAL NAME/LOCAL NAME David Ortiz "Big Papi" Bridge		27-YR BUILT 1965	106-YR REBUILT 1998	YR REHAB'D (NON 106) 0000
06-FEATURES INTERSECTED COMB I 90 & MBTA/CSX		26-FUNCTIONAL CLASS Urban Arterial		DIST. BRIDGE INSPECTION ENGINEER J. O'Connor		
43-STRUCTURE TYPE 302 : Steel Stringer/Girder		22-OWNER State Highway Agency	21-MAINTAINER State Highway Agency	TEAM LEADER M. Tetreault		
107-DECK TYPE 1 : Concrete Cast-in-Place		WEATHER Clear	TEMP. (air) 5°C	TEAM MEMBERS M. HAILU, M. ZEROUAL

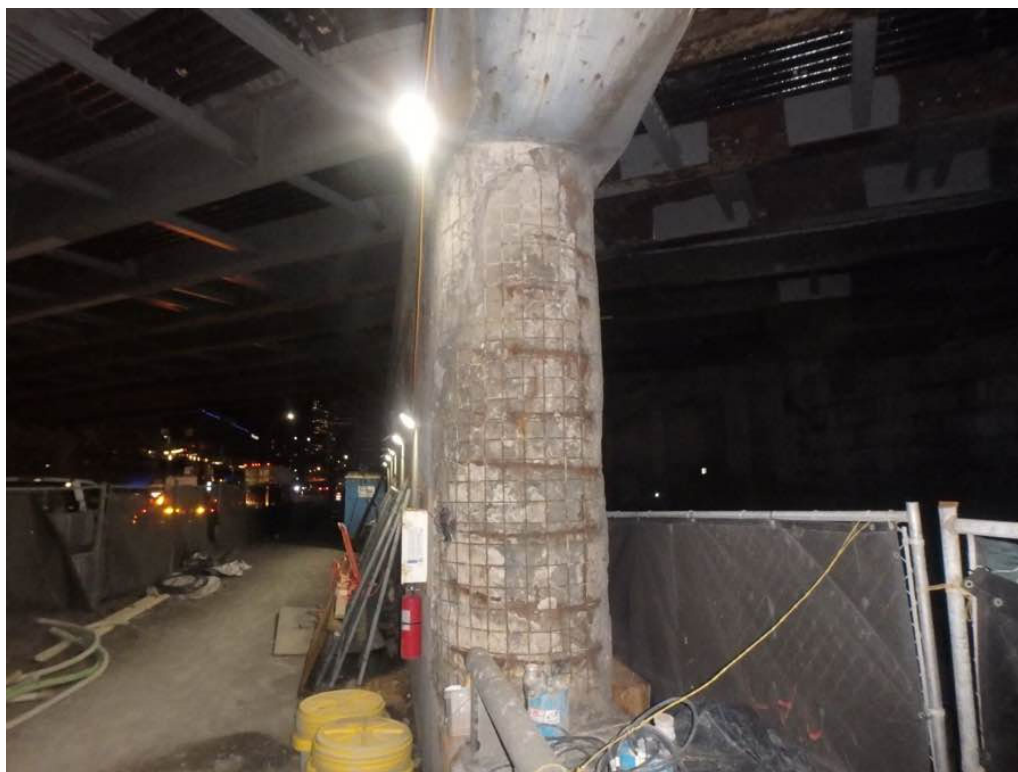
There are previous repairs throughout. In the original concrete there are numerous small areas of minor hollow concrete. At the west end there is cracking, delamination, and moderate to heavy full-height spalling with exposed rusted rebar.

There is minor spalling and hollow concrete around this area. The hollow concrete is at the top 4' and at the bottom 6' at the west end. **See Photo #27.**

Photo 27: At the west end of the pier #1 pierwall there is moderate to heavy, full height, spalling, delamination, and cracking

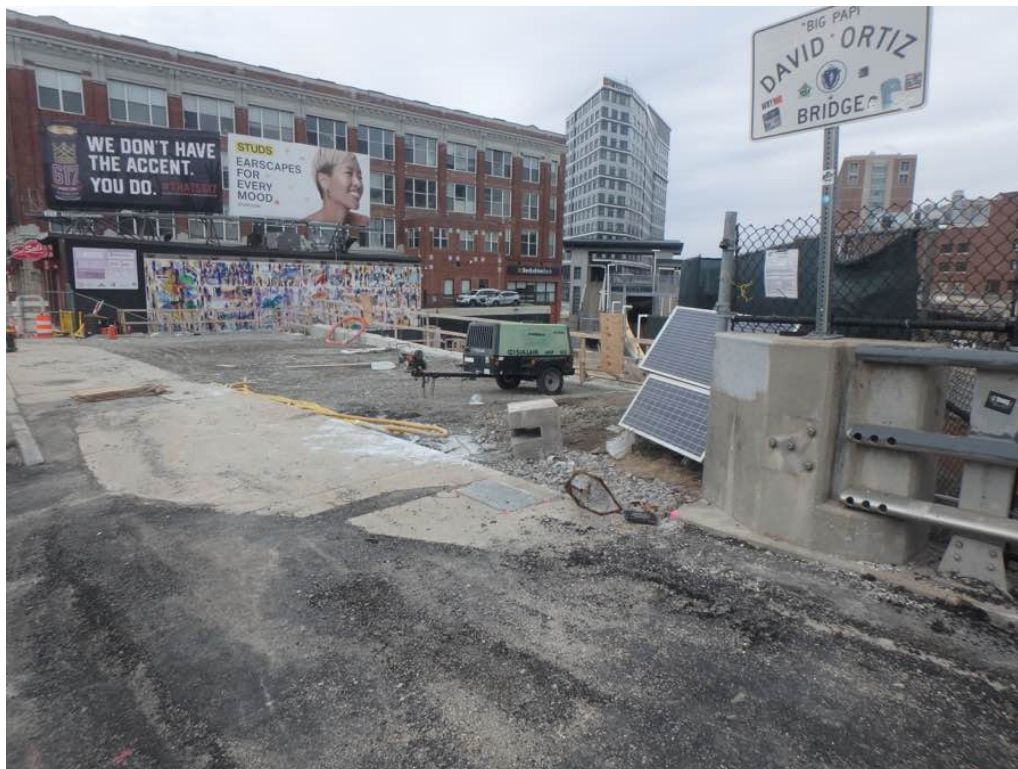
Photo 28: Southwest approach guardrail removed
